Mueller Corporation
Vacuum Metalizing

CERAKOTE VS TEFLON

Cerakote E-100 Blackout coating was tested for head-to-head corrosion resistance against Teflon® Black 958G, Teflon® Metallic Black 420G, and Xylan® 142X coatings, used in marine applications, to prevent. All coatings were applied to plain steel bolts and zinc plated nuts to increase galvanic corrosion rate.

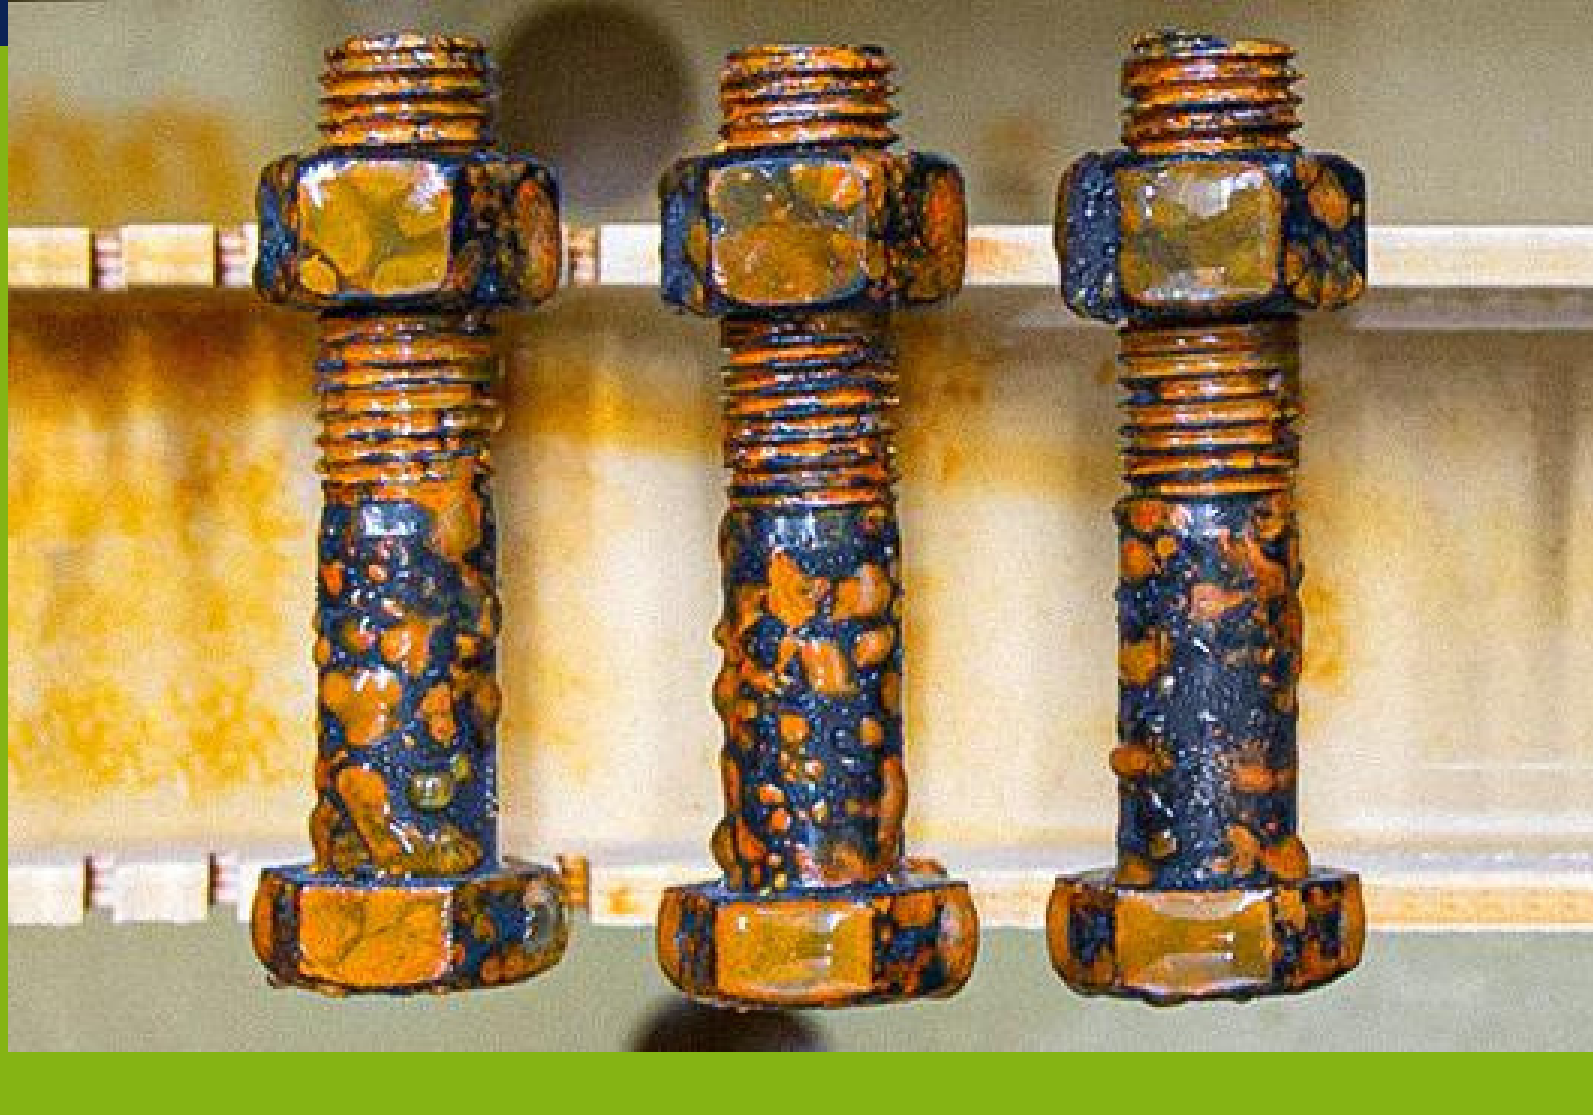
TEFLON ANALYSIS AT 48 HOURS

AT 48 HOURS INTO THE ANALYSIS, BOTH GRADES OF TEFLON® HAD SURPASSED THE 3% FAILURE STANDARD ON THE BODY OF THE BOLTS. TEFLON® BOLTS WERE PULLED FROM THE CHAMBER AT 640 HOURS WITH 100% CORROSION.

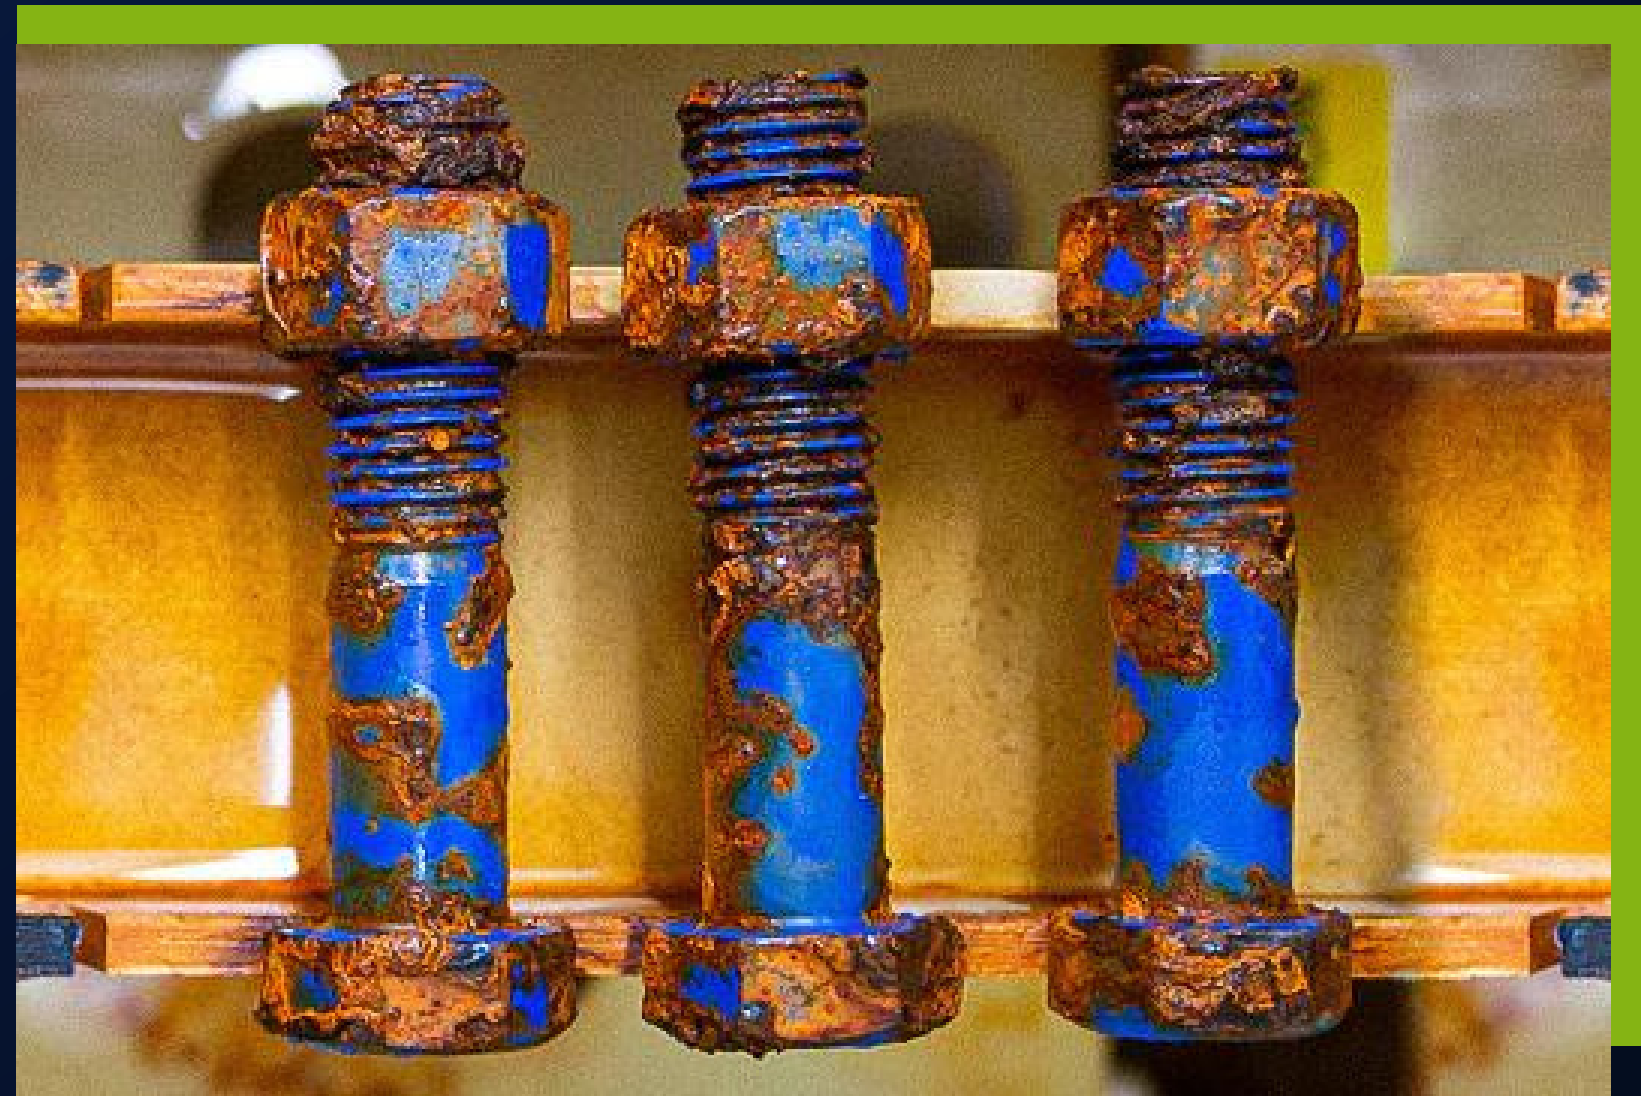
XYLAN RESULTS AT 530 HOURS

THE XYLAN® BOLTS REACHED THE 3% FAILURE STANDARD AT 530 HOURS IN THE CHAMBER. THESE SAMPLES WERE REMOVED FROM THE CHAMBER AT 1,871 HOURS WITH APPROXIMATELY 60% CORROSION.
